# Vibration Test Facility

# Reduction in Internal Pulser Wear as Improvements were Implemented

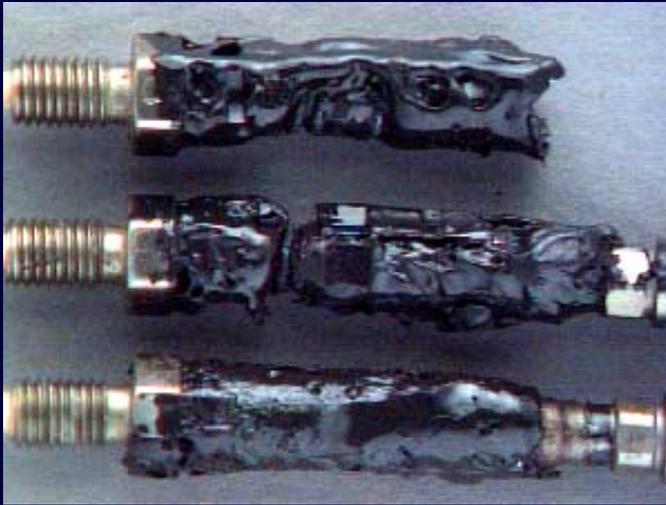
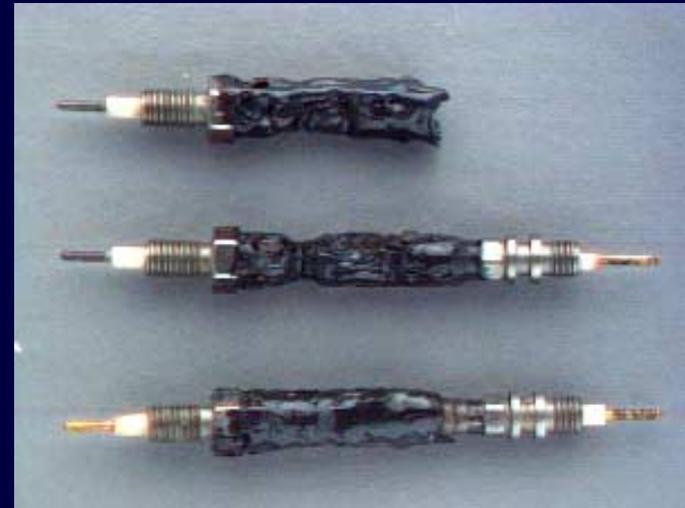
# Connectors After Thermal Exposure

- High Temperature Exposure of electrical connectors in a saturated steam environment caused severe degradation of the Viton rubber. This was demonstrated and an alternate material was selected by closed-cavity testing.

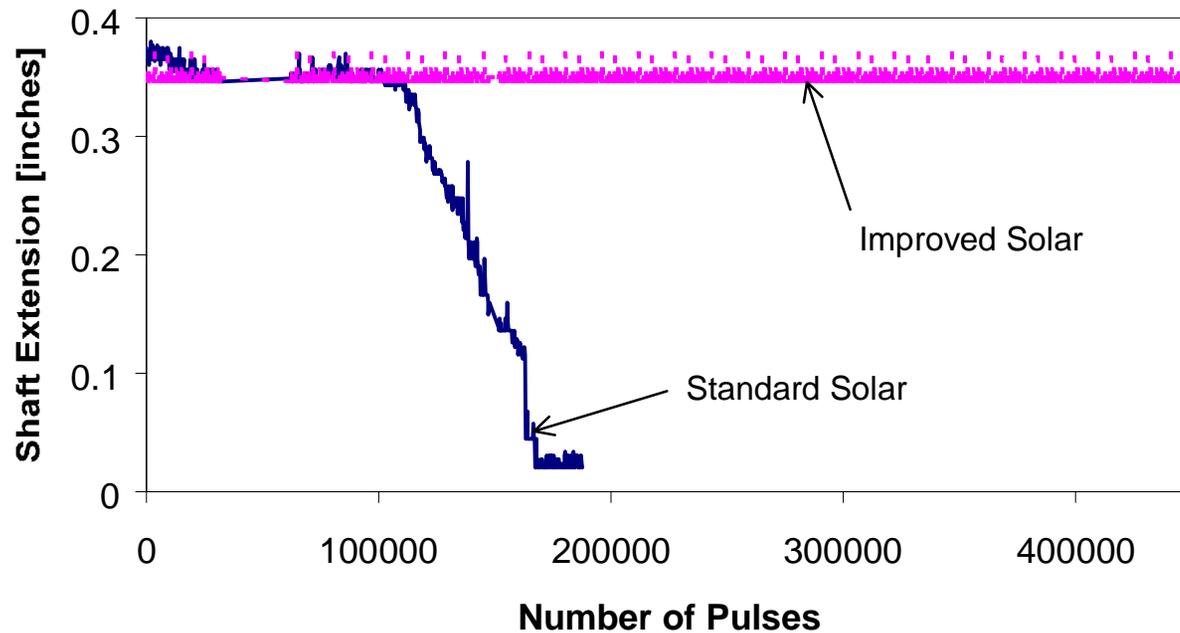
Poppet Shaft Extension Vs. Number of Pulses

# Pulser Poppet Shaft Extension is Reduced by Wear Debris in Control Valve

100,000 cycles = 35 hours

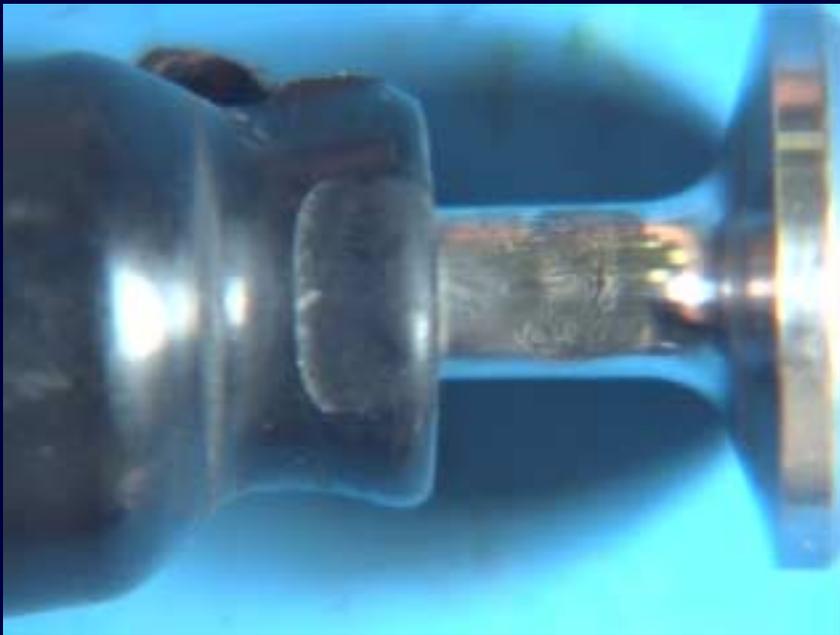
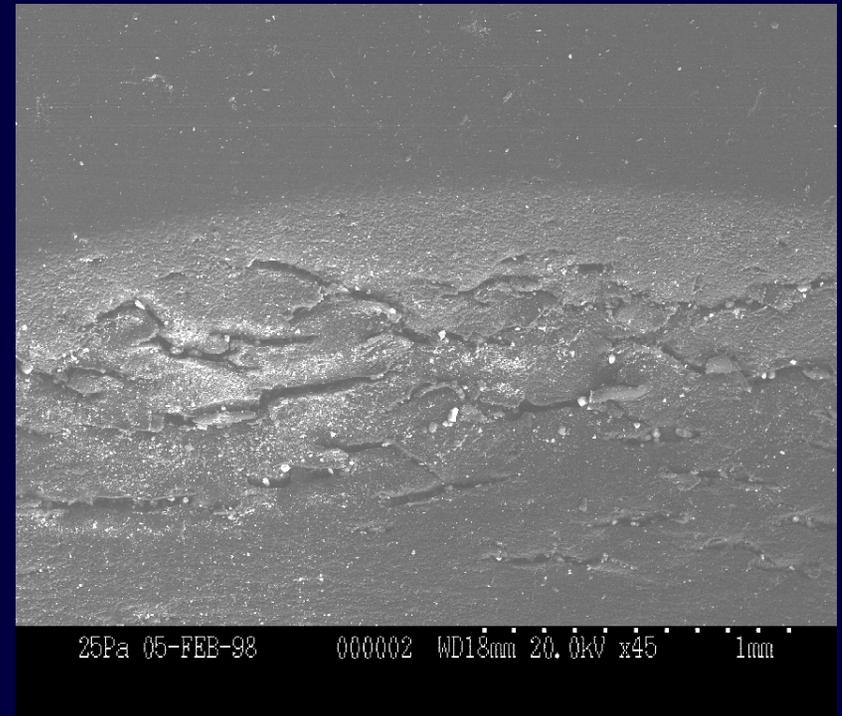
# Poppet Shaft wear and Rubber Boot Damage Commonly Observed with Boot Design

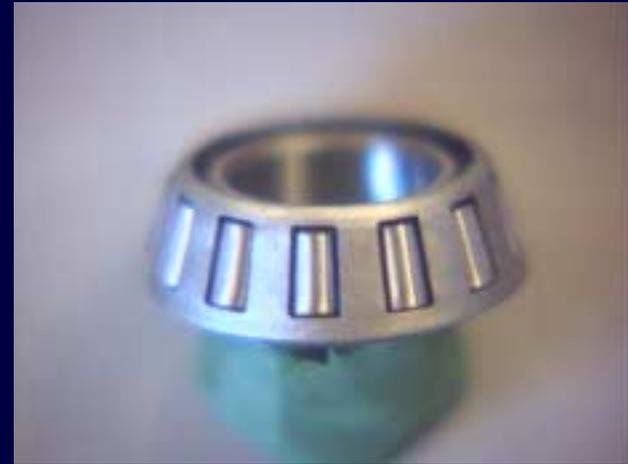
# Tapered Roller Bearing

- Top image is with latest design improvements after 207 hours of HT/HP testing
- Bottom image shows severe galling damage to original design after 29 hours of HT/HP testing

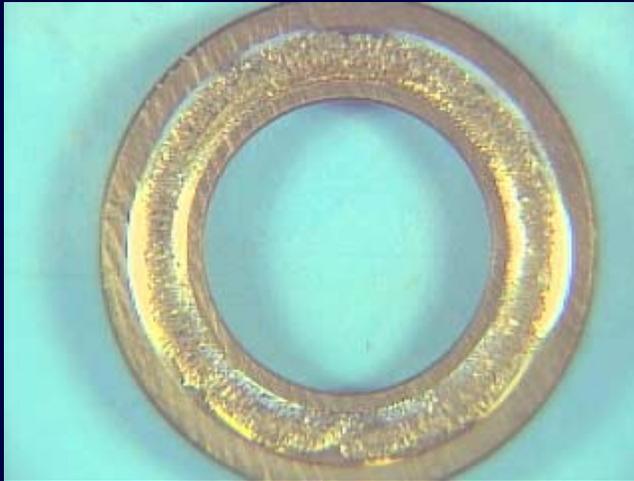
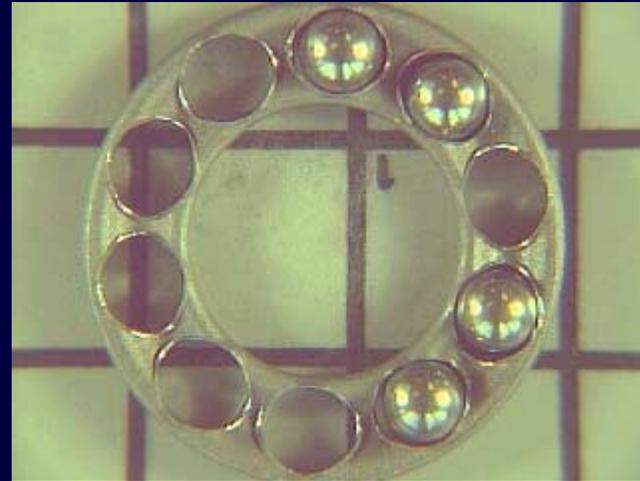
# Angle Plate Bearings and Race

- Original design with stamped cage, and standard bearing ball and race materials after 29 hours of HT/HP testing

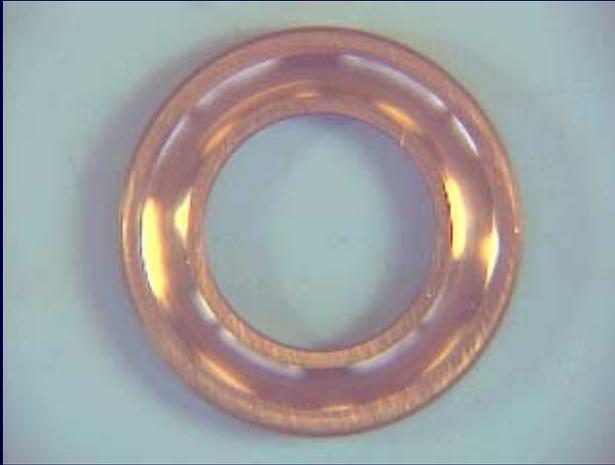
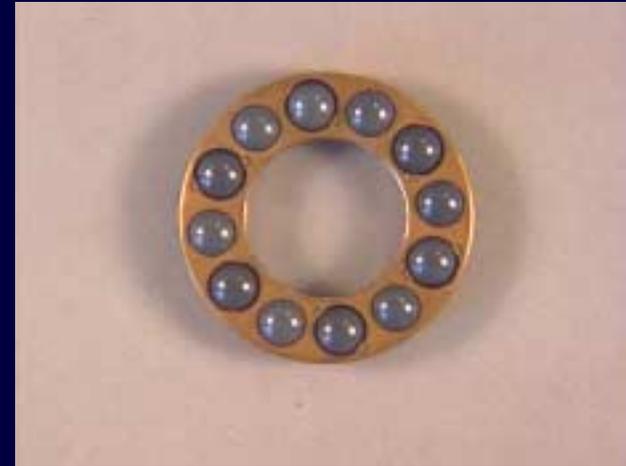
# Angle Plate Bearings and Race

- Latest Design with machined cage, silicon nitride balls, and M50 races after 207 hours of HT/HP testing

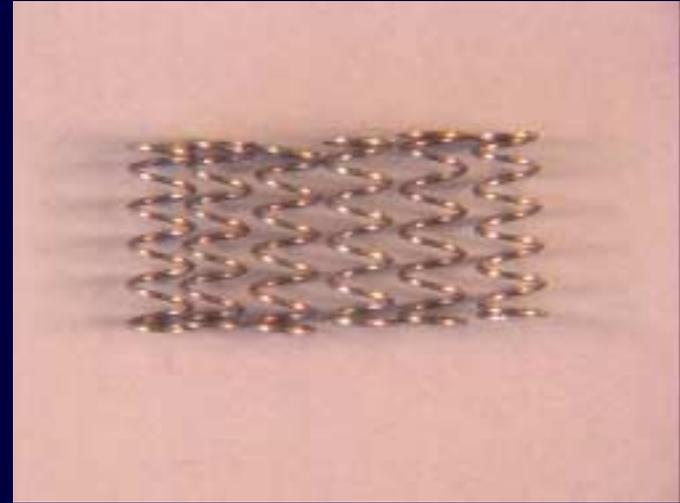
# Positive Displacement Pump Piston Return Springs

- Top image shows springs after 207 hours of HT/HP testing with latest design improvements
- Bottom image shows worn and broken springs from a earlier design after HT/HP testing

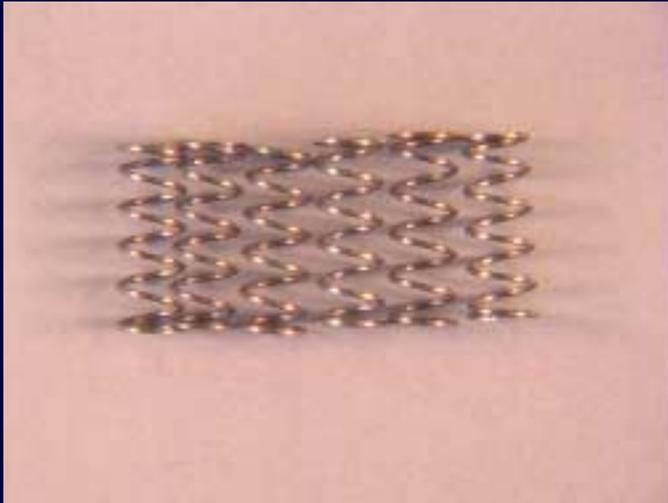
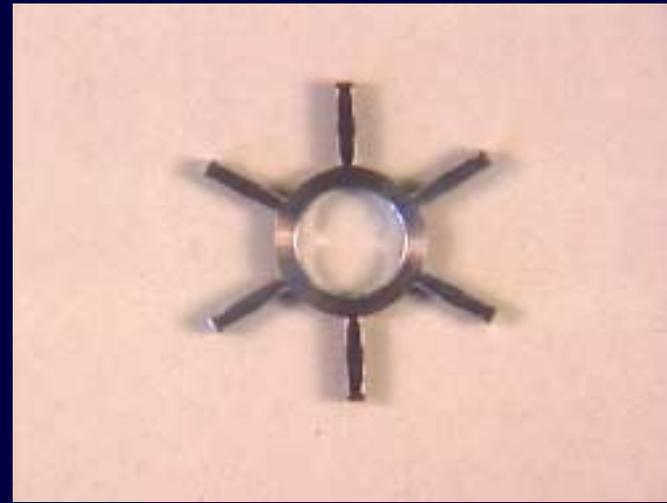
# Positive Displacement Pump Piston Return Springs

- Springs and Piston Anti-rotation spider after 207 hours of HT/HP testing with latest design improvements
